## Case Report

## Aesthetic Correction of Peg Lateral with Resin Composite using Putty Index Technique : A Case Report

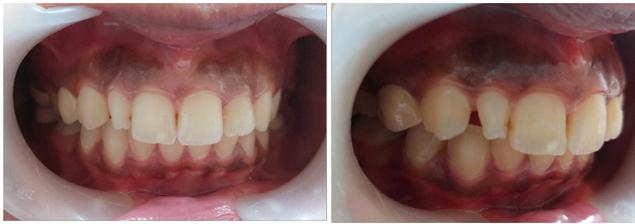
Fig. 1: Pre-operative photographs

A 20-year-female patient reported to the Department of Conservative Dentistry and Endodontics with chief complaint of irregular appearance of upper front tooth. Patient history revealed no systemic diseases or medical conditions. Intraoral examination revealed a peg shaped lateral incisor with 12 (Figure 1). Following clinical and radiographic evaluation direct composite restoration was planned and informed to the patient.

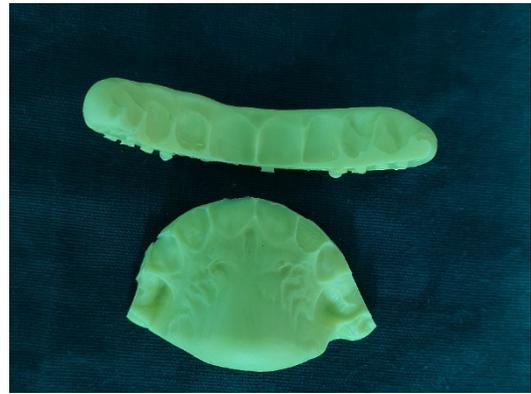
Fig. 4: Putty Index

Maxillary and mandibular diagnostic impressions using irreversible hydrocolloid were made (Figure 2) and diagnostic cast were obtained on to which, wax-up was done on 12 using Ivory wax (Figure 3). A palatal putty silicone index using vinyl polysiloxane was fabricated (Figure 4). The palatal half was then checked for the fit to serve as the reference guide to reconstruct the palatal aspect (Figure 5). Following shade selection, bevels were incorporated both on the labial & palatal aspects. Tooth was etched, bonded

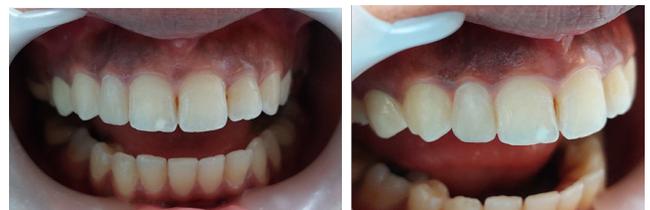
Fig. 6: Post-operative photographs

and composite build up was done. Finishing and polishing was done using the composite polishing kit (Figure 6). Oral hygiene instructions were given to the patient. The patient was instructed to floss regularly and also to avoid pigmented liquids that may cause staining of the restoration.
